Jordan Cove Watershed, Waterford, Connecticut

Runoff and pollution monitoring has demonstrated the benefits of permeable interlocking concrete pavements in the U.S. EPA funded Jordan Cove Urban Watershed National Monitoring Project. Driveways and a municipal street were paved in this low-impact, environmentally sensitive residential development.

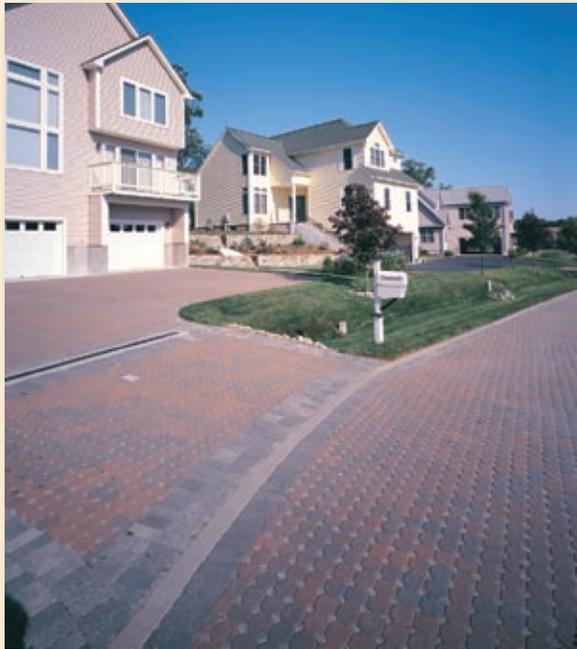
Runoff quantity and quality from driveways were monitored from water exiting slot drains.

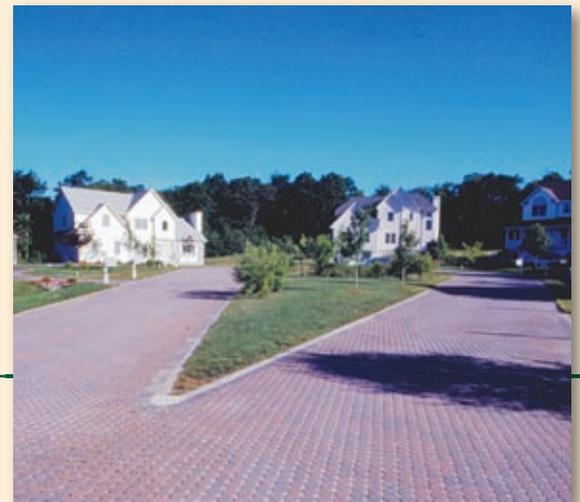
Rather than being paved, the center of the cul-de-sac in Glen Brook Green subdivision provides a bioswale to absorb runoff and overflow from the permeable pavement.
