Tech Spec Guide

Interlocking Concrete
Pavement Institute®

Repair of Utility Cuts Within Interlocking Concrete Pavements

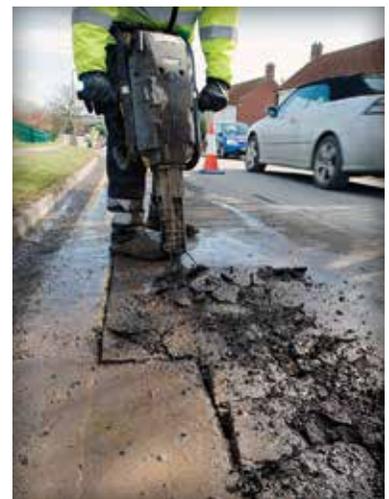
Figure 1. Repairs to utilities are a common sight in cities, incurring costs to cities and taxpayers.

North American cities have thousands of utility cuts made in their streets each year. Figure 1 shows a daily occurrence in most cities: repairs to underground utility lines for water, sewer, gas, electric, steam, phone, fiber-optic, or cable services. A sample is given below of the number of annual utility cuts in a few cities.

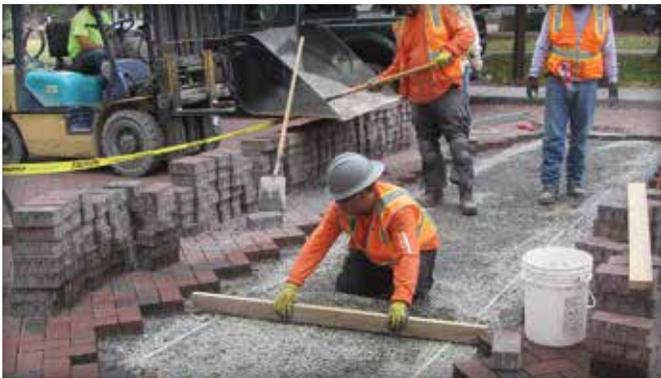
Figure 2. After compaction of the base, bedding material is screeded.

Figures 2, 3, 4, 5 and 6 show the process of repair and illustrate the continuity of the paver surface after it is completed. The

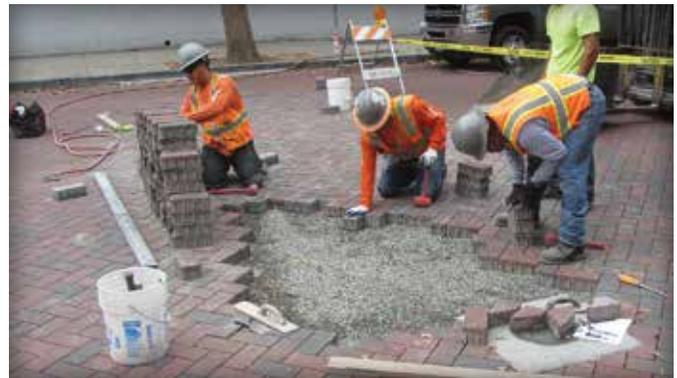
Figure 3. Once smoothed and joined with undisturbed materials at the opening perimeter, the bedding receives concrete pavers.

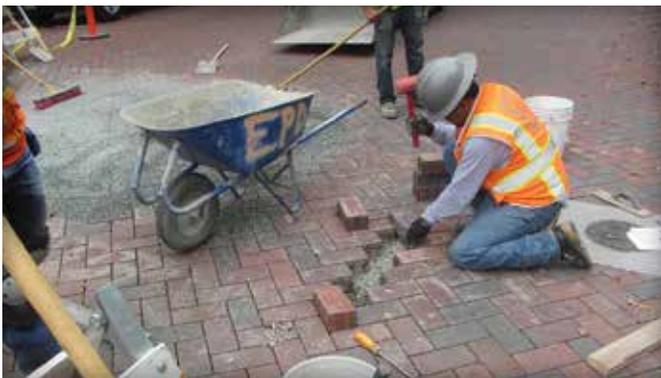
Figure 4. Reinstatement using the same pavers continues following the existing herringbone paving pattern.

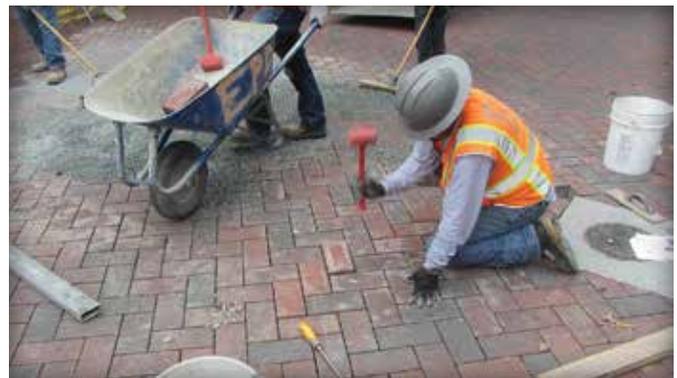
Figure 5. The final paver is inserted, the reinstated area compacted, joints filled, and compacted again. There are not cuts or damage to the pavement surface.

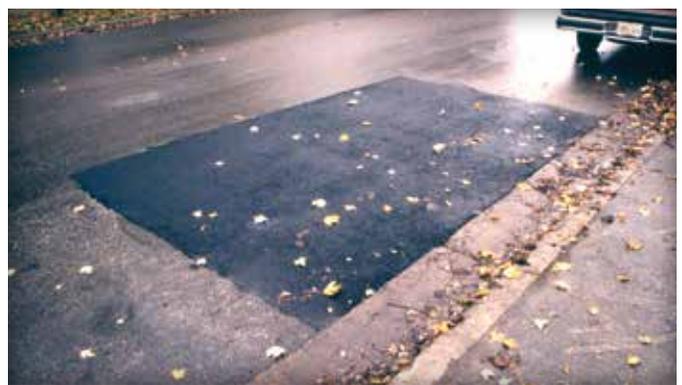
Figure 7. Pavement damage from settlement and shrinkage of cold patch asphalt.

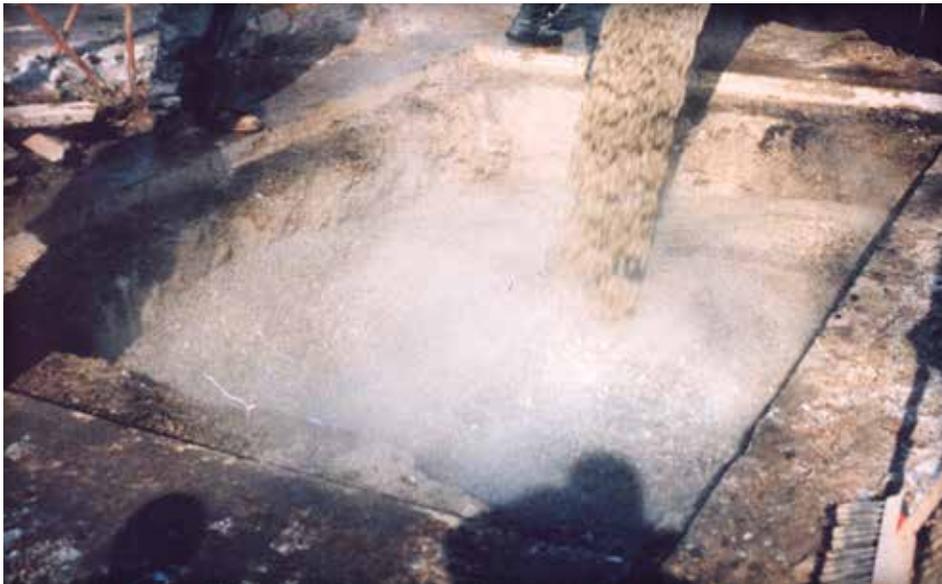
Figure 8. Low density concrete fill (unshrinkable fill) poured into a utility trench from a ready-mix concrete truck.

Unshrinkable fill poured into a trench is shown in Figure 8. The fill flows into undercuts providing additional support, and in places where the soil or base has fallen from the sides of the trench. These places are normally impossible to completely fill and compact with aggregate base or backfill material.
